1st work report
(September 11th 2024 to January 5th 2025)

**on the construction of one school building holding 2 classrooms, office, storage
room and toilets
for the public preschool of Kpakpa-Agbagoulè
District of Lema
Municipality of Dassa-Zoumé
Republic of Benin**

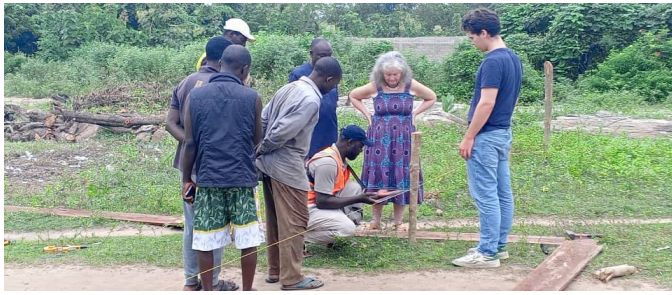
The next day we create the battering frame.

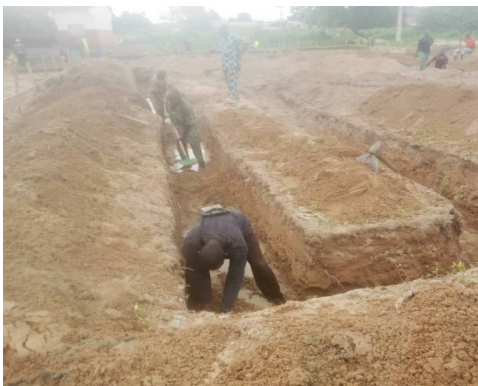
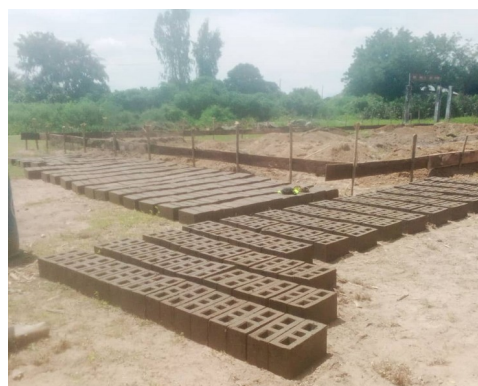
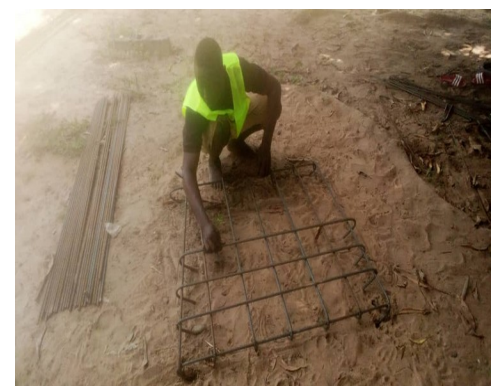
While the people from the village dig the foundation trenches, the bricklayers make the building blocks and the iron benders make the iron inserts.

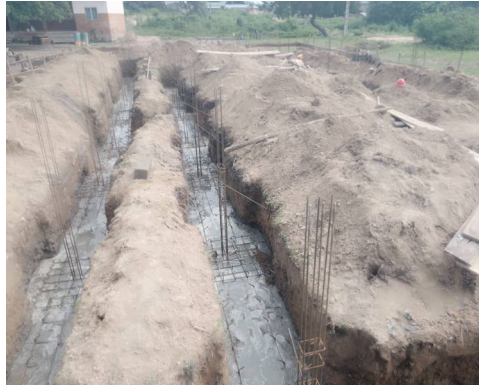
Finally, the foundation base is poured and the pillars are arranged.

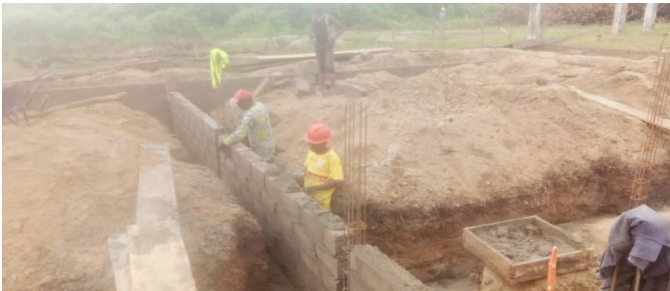
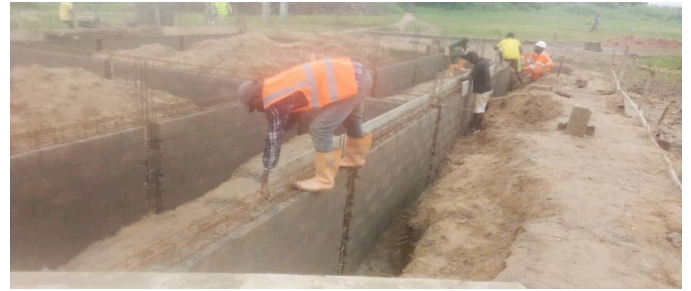
The foundation walls are then built up to the lower iron anchor.

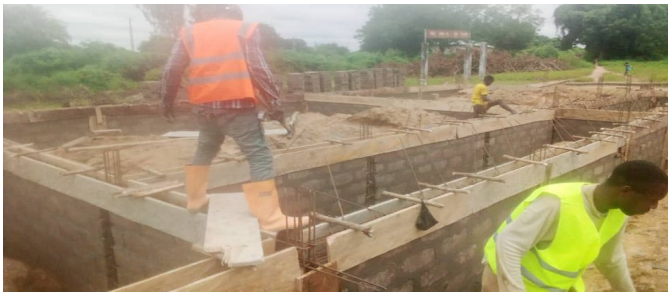
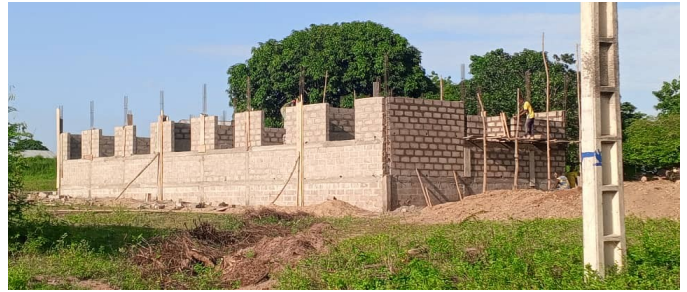
The lower iron anchor is encased and cast. The walls of the building are built on top of it.

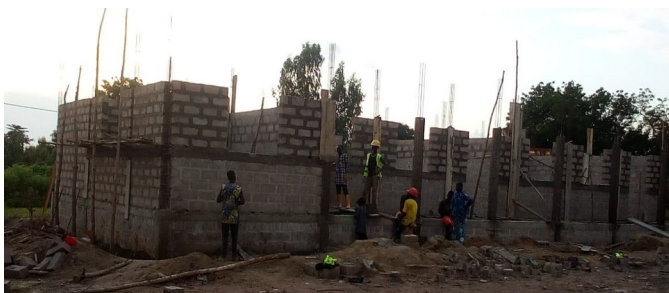
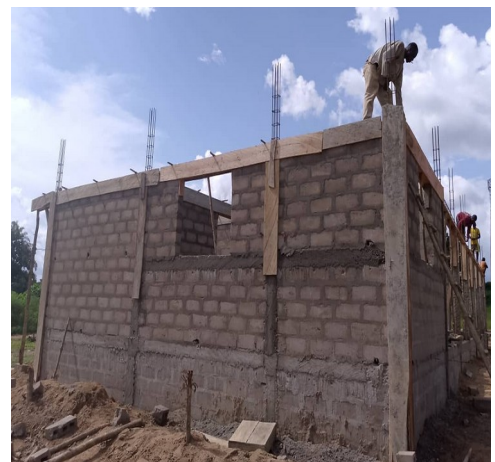
A small iron anchor is inserted below the window openings. Then the walls are built up to the window lintel. The pillars of the veranda are cast. Then the iron anchor above them is cast in one piece.

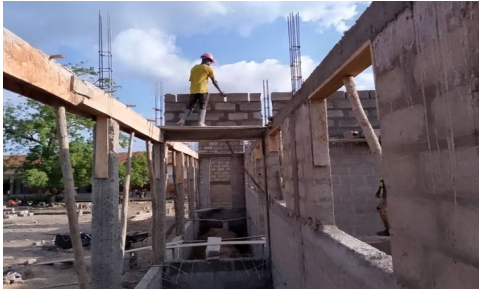
On the upper iron anchor
the walls are built.

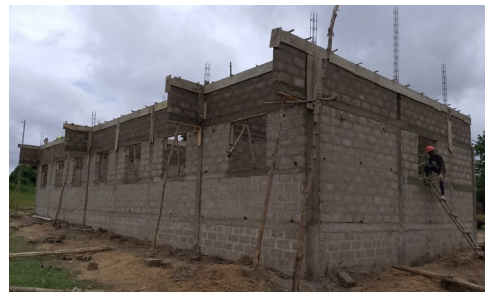
And it continues to the
iron anchor below the roof.

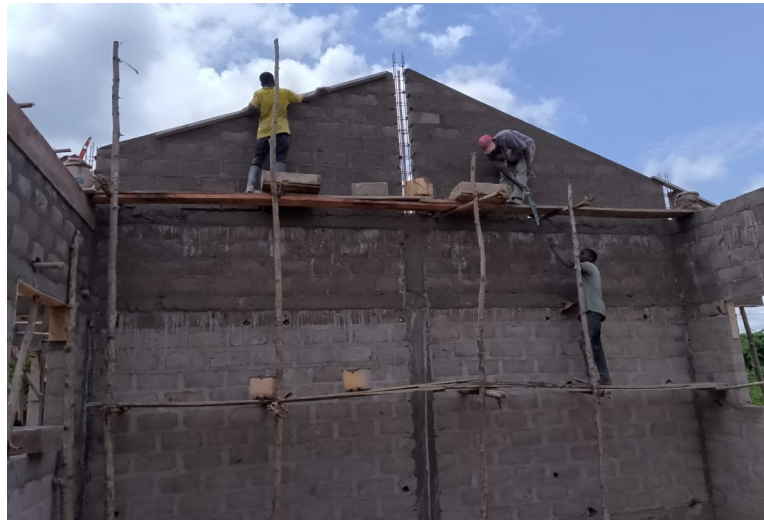
The gables are erected above the last iron anchor.

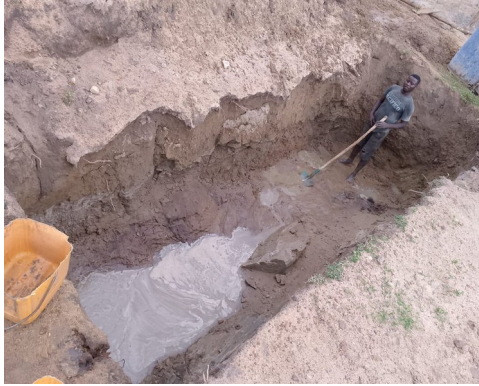
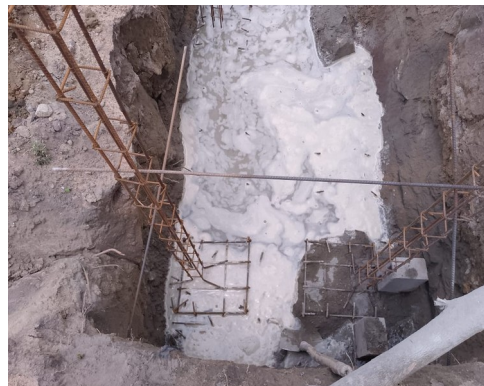
The toilet pit could not be dug deeper than 2 m because water soon began to rise. A 40 cm thick layer of concrete mixed with Sikalite and Sikalutex was poured in as a foundation base. A second layer of the same thickness was poured after the iron inlays of the pillars were inserted.

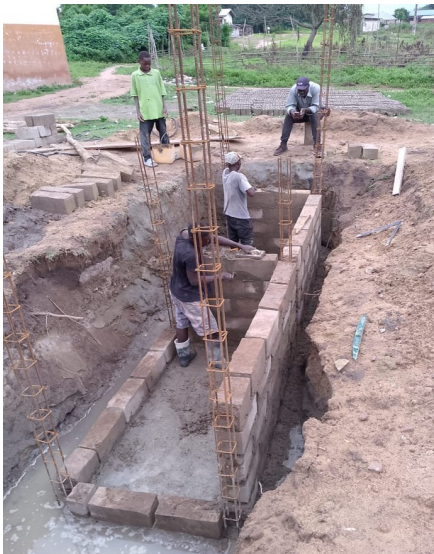
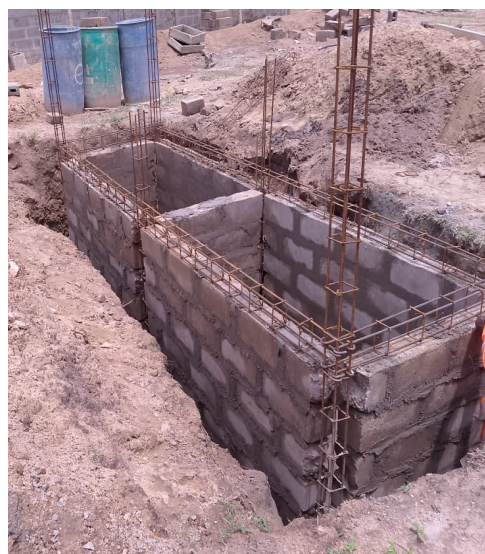
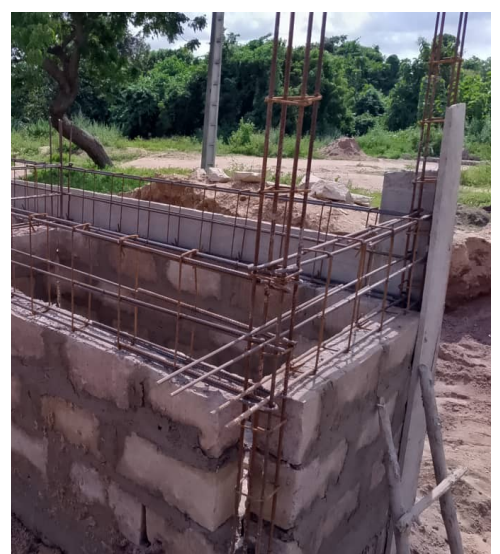
On this foundation the walls were erected.

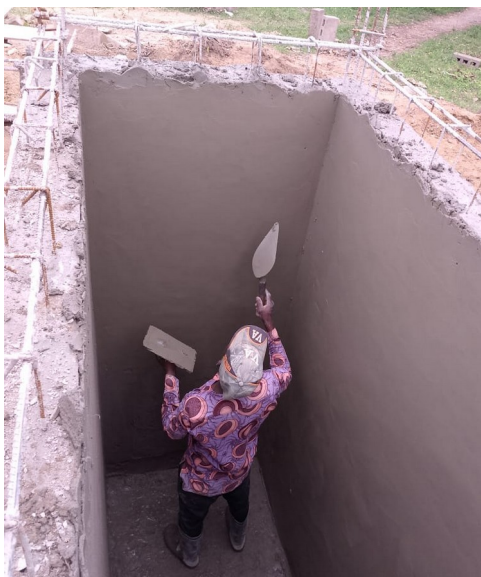
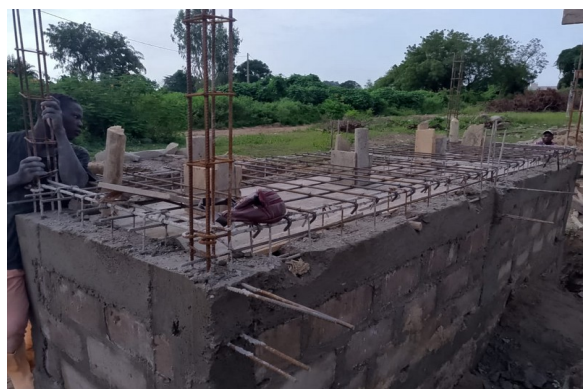
After the walls of the toilet pit were plastered with Sikalite and Sikalutex,

the pit was closed.

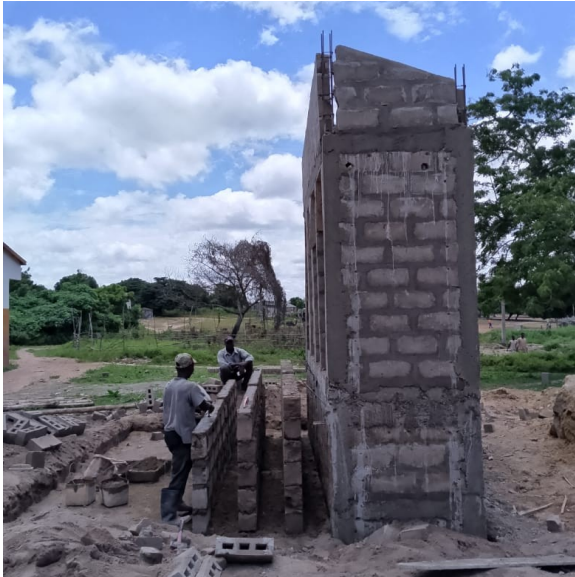
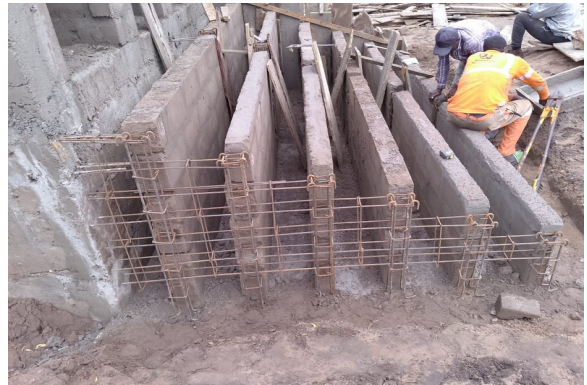
The toilet block was built and the staircases were constructed. The stairs were attached to the block with iron.

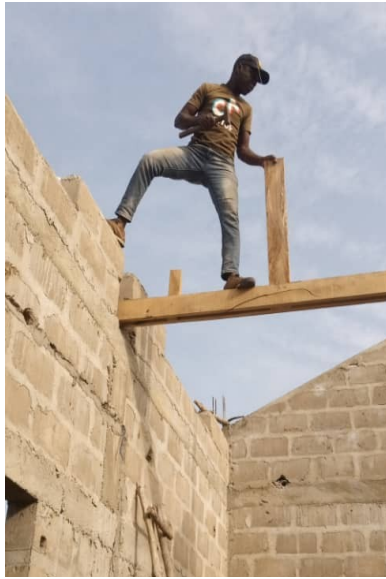
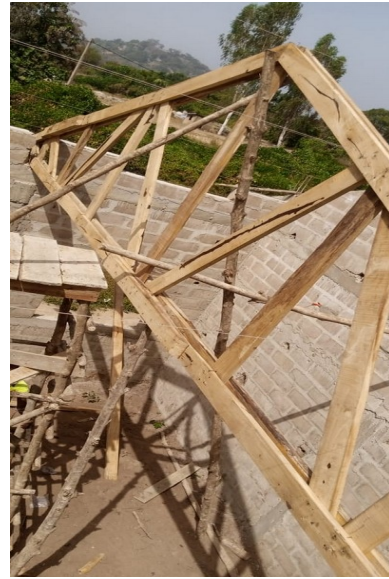
Then the cross ties are manufactured.

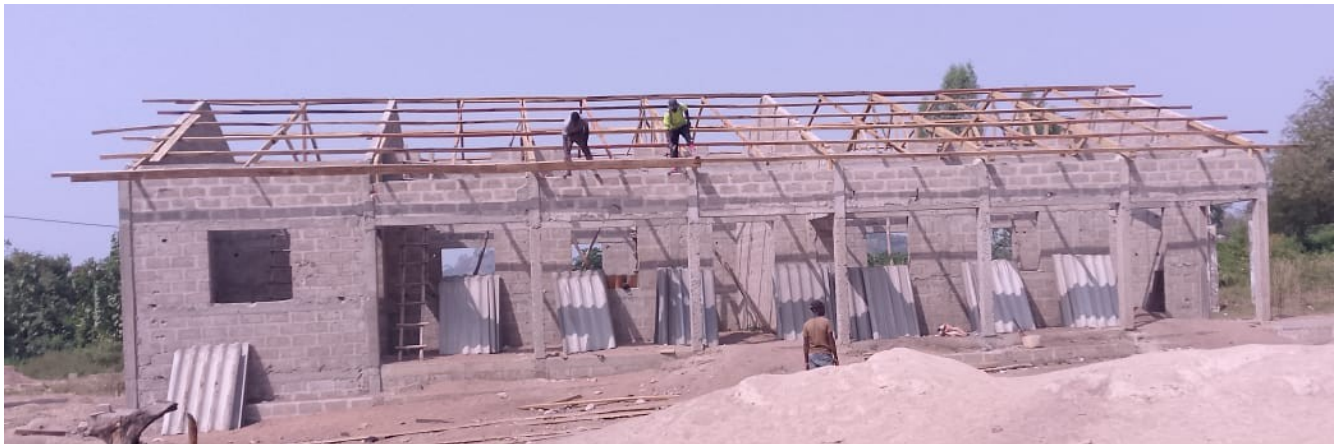
The longitudinal beams are attached above

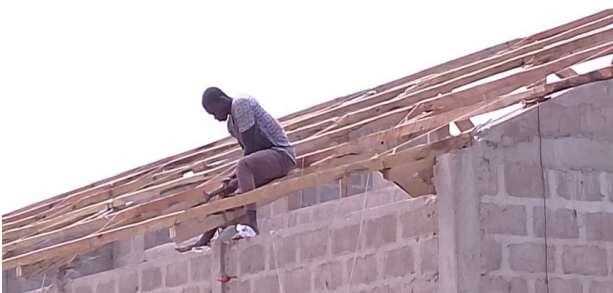
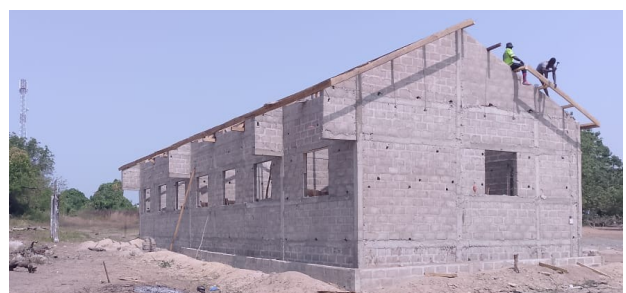
and the roof is tied to the building with the iron rods. To the ends of the beams boards are added to make the roof truss look neat.

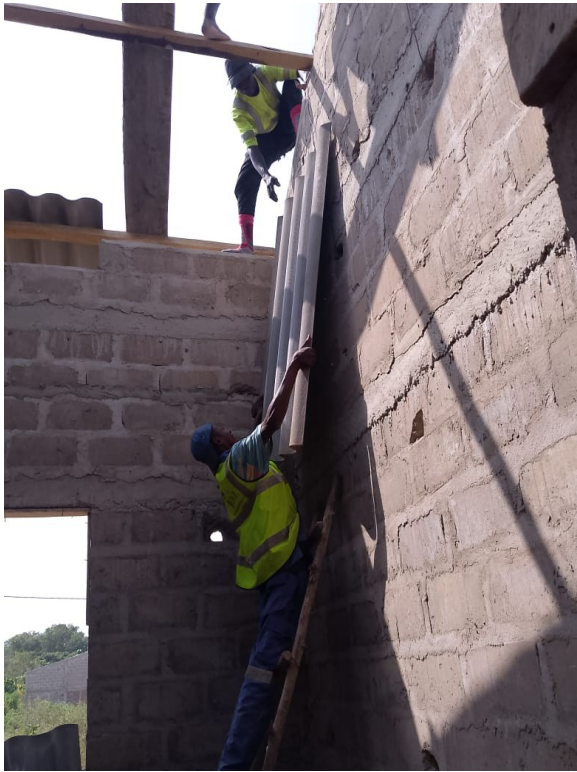
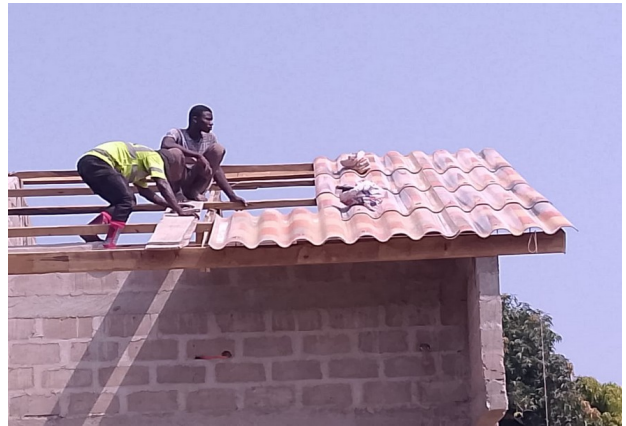
The roofing sheets are then screwed on.

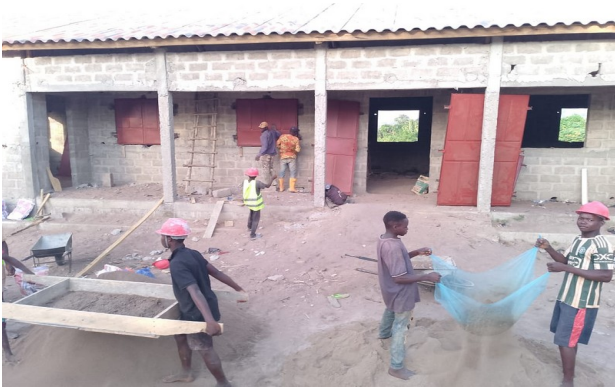
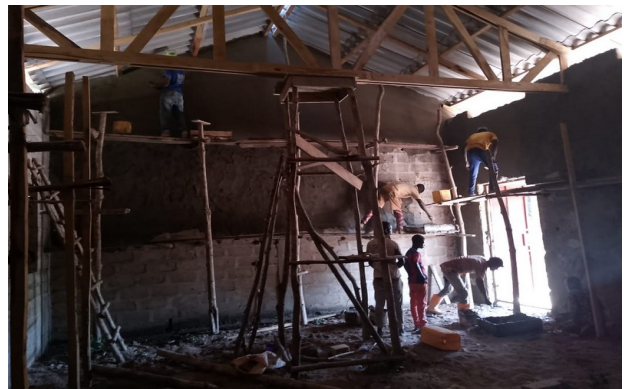
After the sand has been sieved, the plastering work begins.

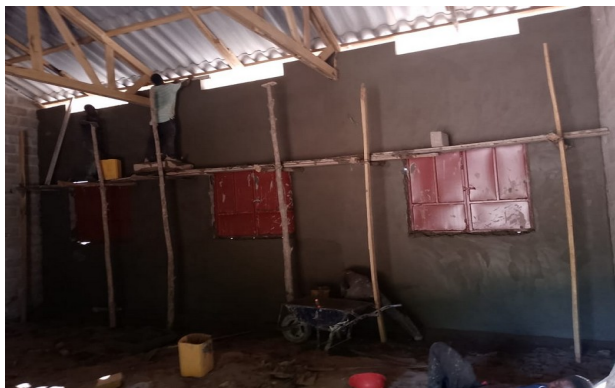
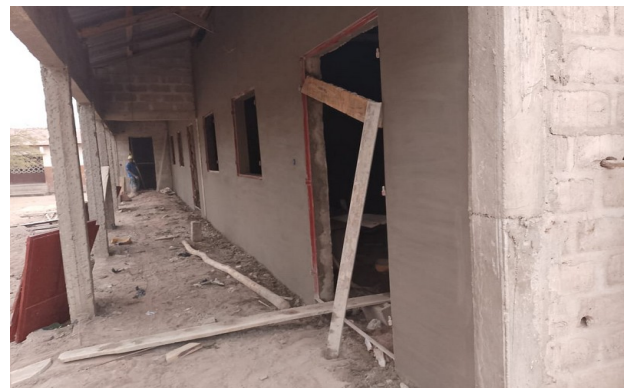
First inside the classrooms, then the outside walls.

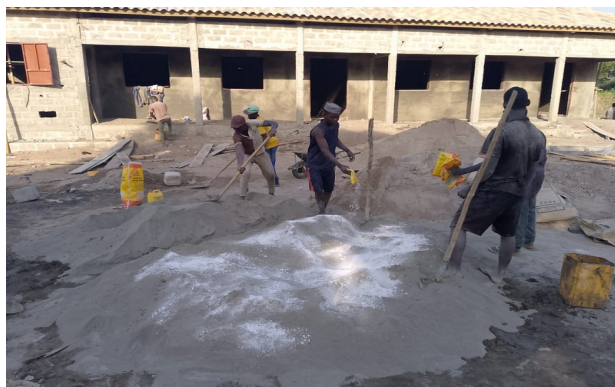
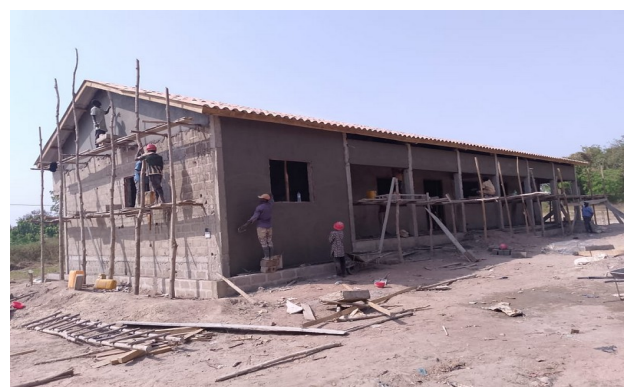
Sikalite and Sikalatex are mixed into the plaster for the exterior walls to prevent rainwater from penetrating the plaster.

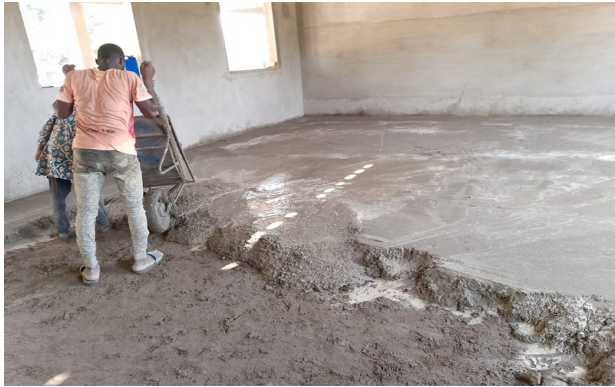
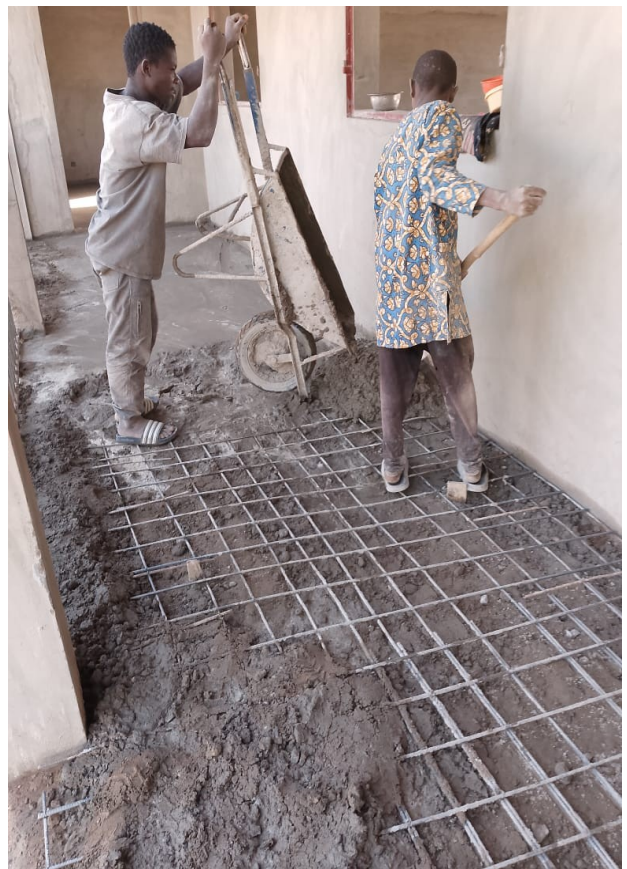
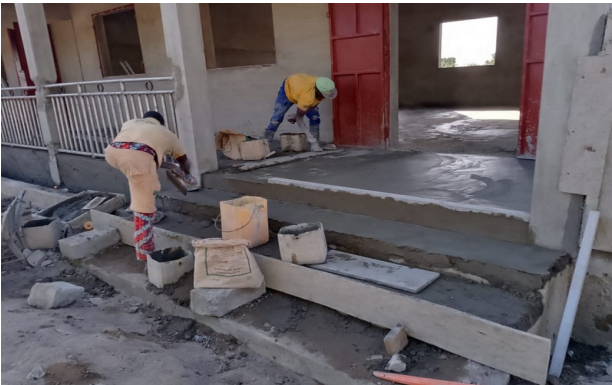
Next, the soils are compacted and cemented.

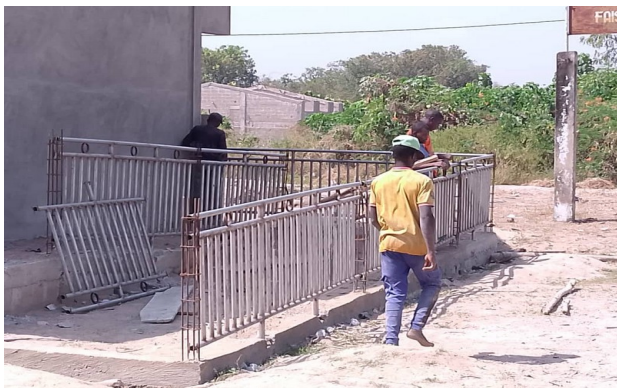
The staircases are carefully finished and the railing of the ramp is installed.

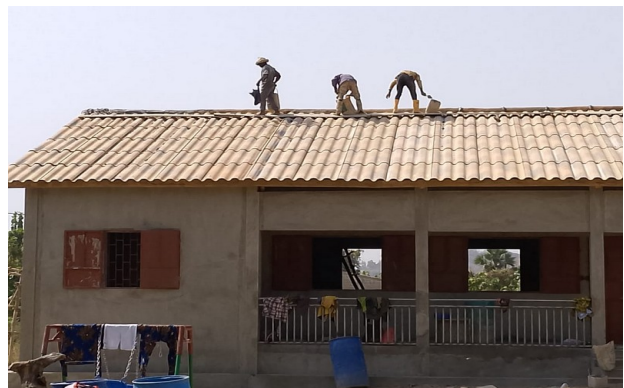
Finally, the roof ridge is closed.
