1st work report
(October 1st to November 19th, 2024)

**on the completion of a building holding 4 classrooms and construction of toilets
for the Catholic primary school St. Pierre
administrative district Sinwe-Lego
municipality of Agbangnizoun
Republic of Benin**

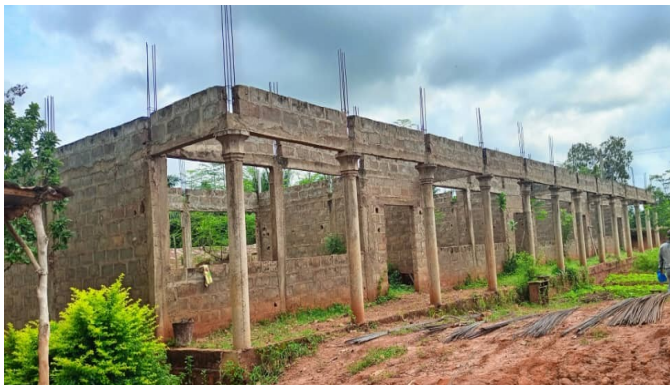
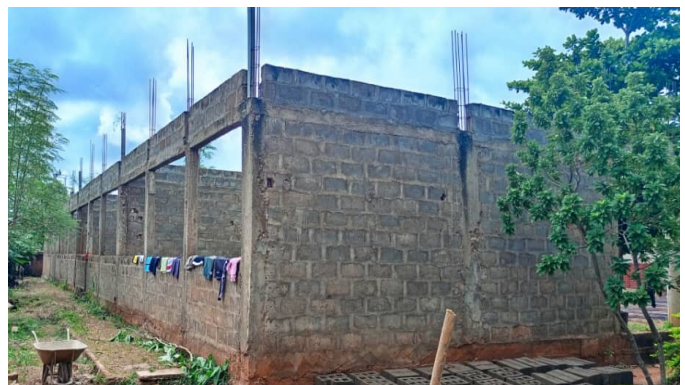
Together with the bricklayers, we take an over view of the building:

The window openings are too wide and there is no iron anchor below the window openings, the doors are too low, the building structure is good.

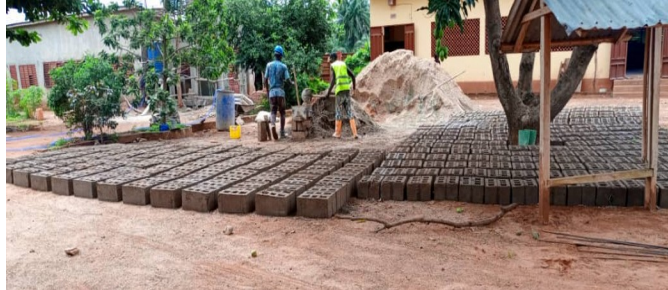
After the sand arrives, building blocks are made.

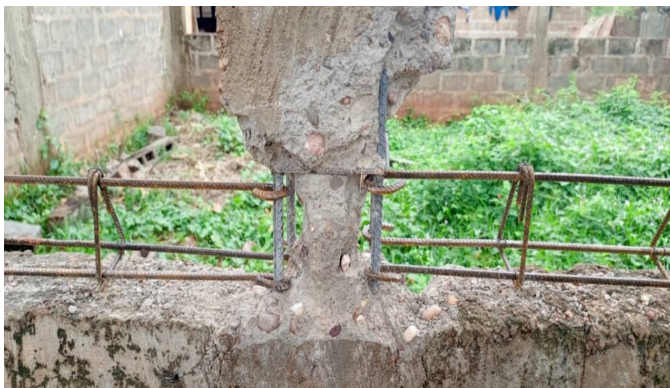
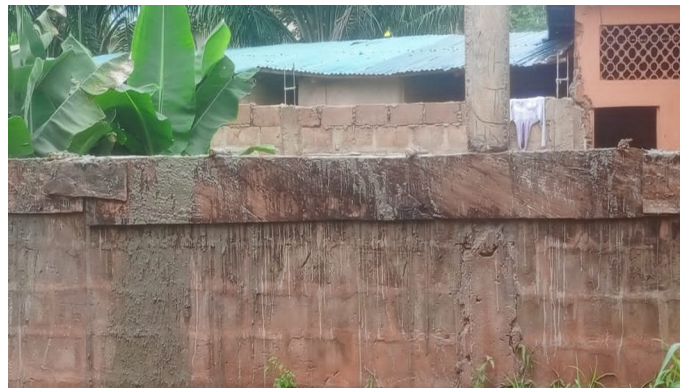
The iron benders first make the iron inserts for the small anchor. Then the inserts are connected to the iron in the pillars. The anchor is then formed and cast.

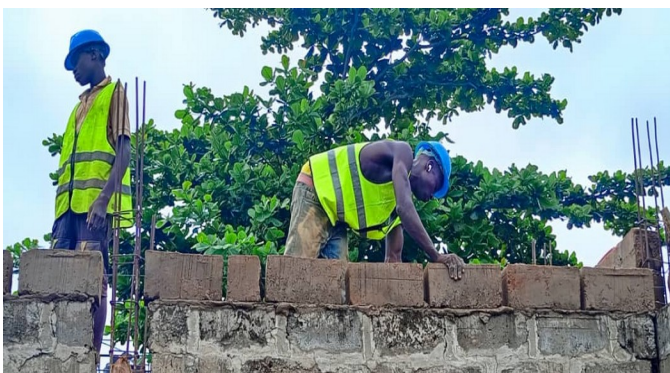
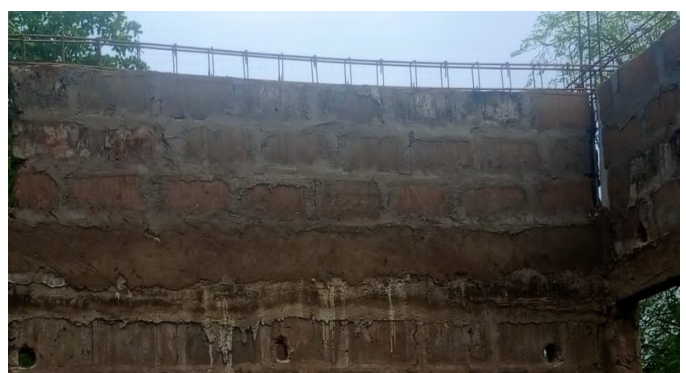
The walls are raised and the supports for the roof are installed. Then the iron anchor below the roof is prepared.

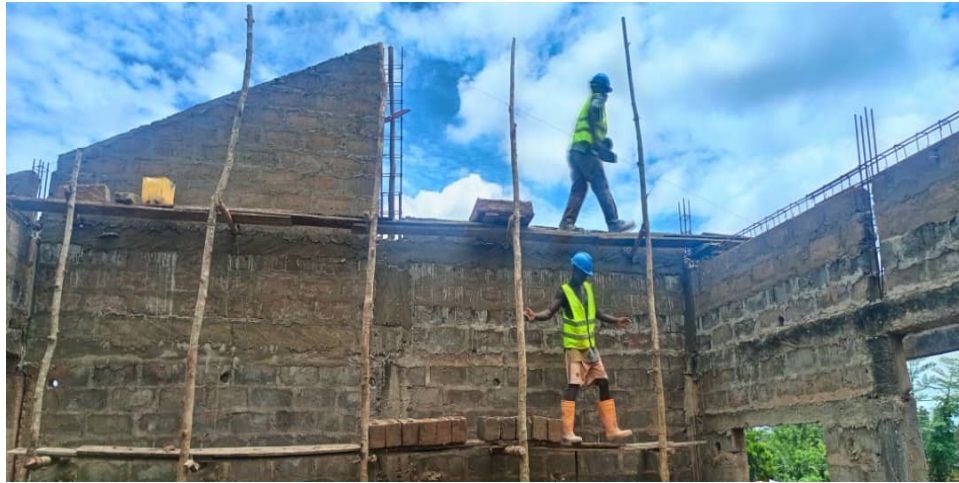
After the iron anchor has been cast, the gables are built.

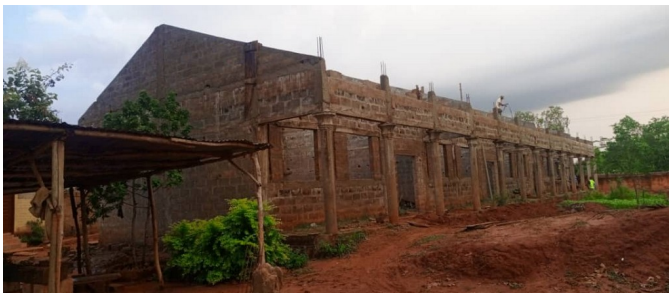
All gables are finished.

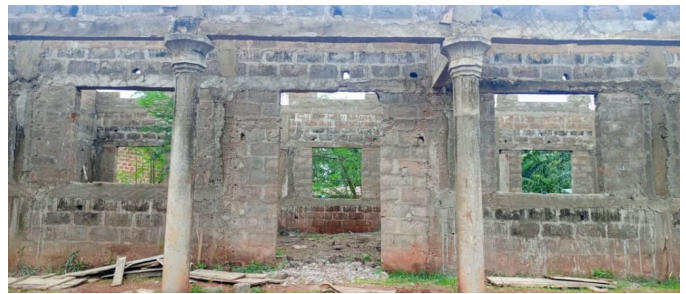
The doors were enlarged

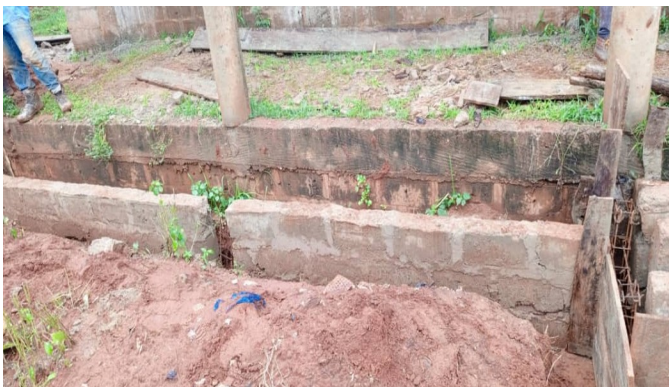
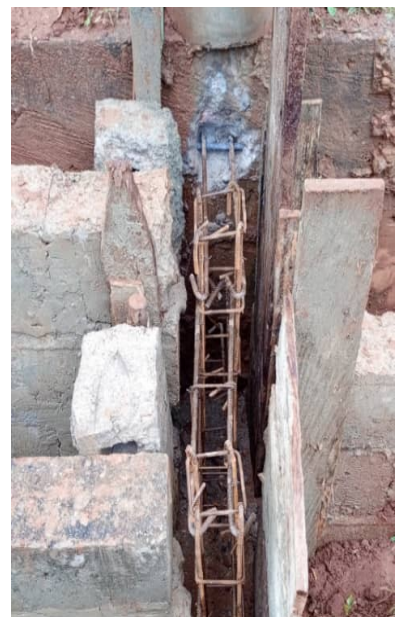
A wall to protect the foundation is built around the building and the staircases are connected to the building.

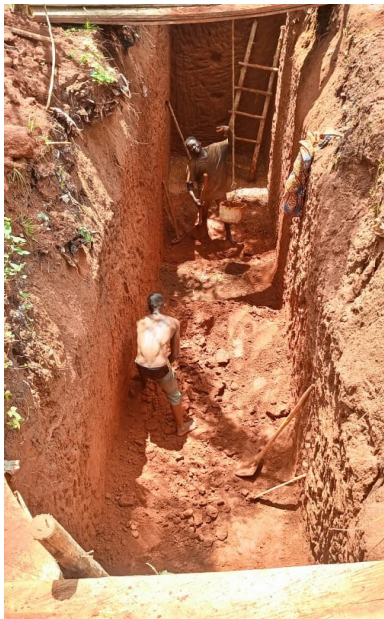
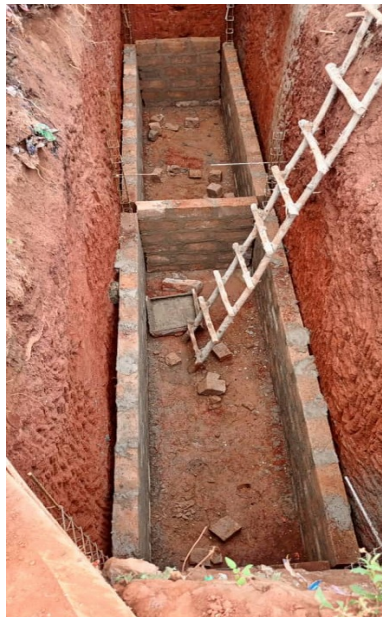
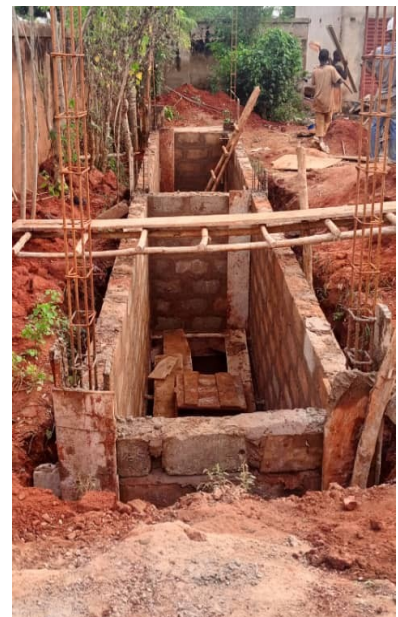
Hard work is also being done in the toilet pit.

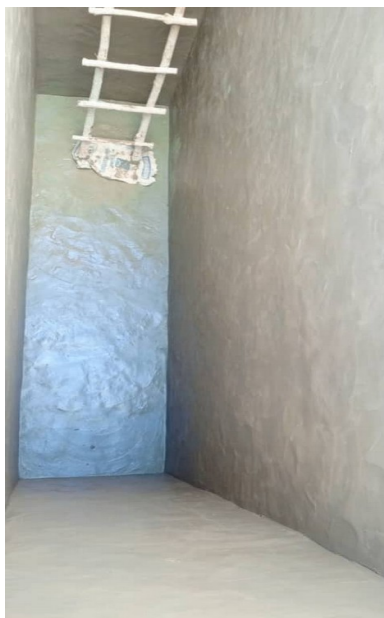
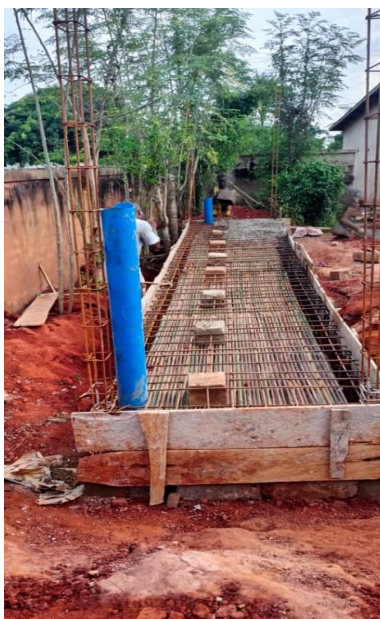
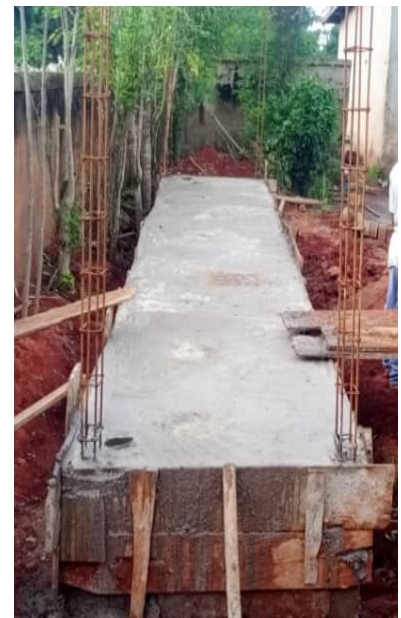
The toilet pit is plastered using sikalite and sikalatex and then closed.

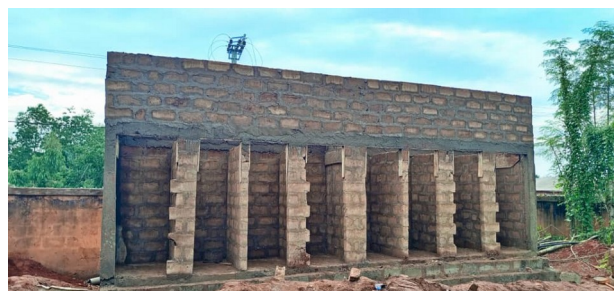
The toilet block is built on top of it.

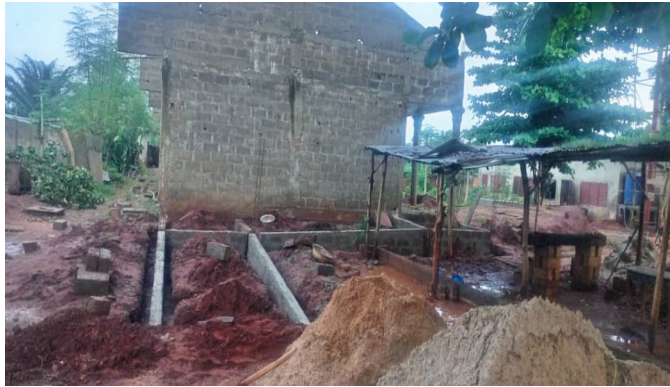
The ramp is also being built onto the building.

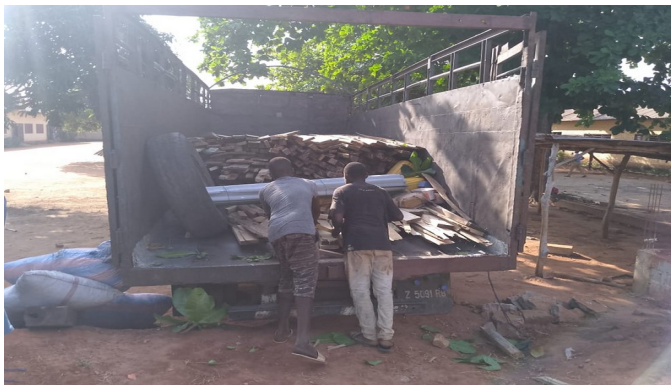
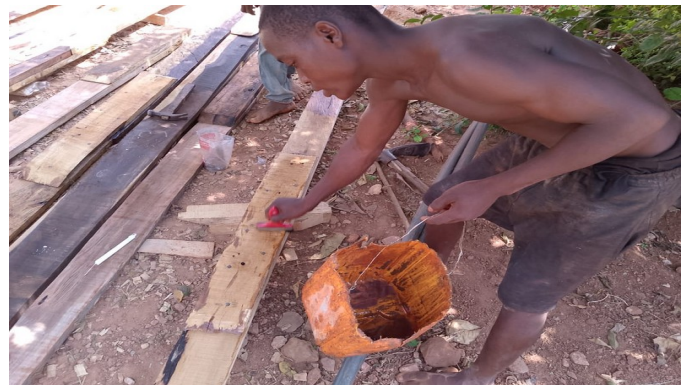
The building now has to dry for a month before the roof can be put on. On November 11th the time has come. The carpenters travel to Sinwe-Lego. Our supervisor is among them. Immediately after their arrival they look for planks for the roof truss, take them to the sawmill and the carpenters oversee the cutting. A few days later the cut planks arrive at the construction site. They are coated with insect repellent.

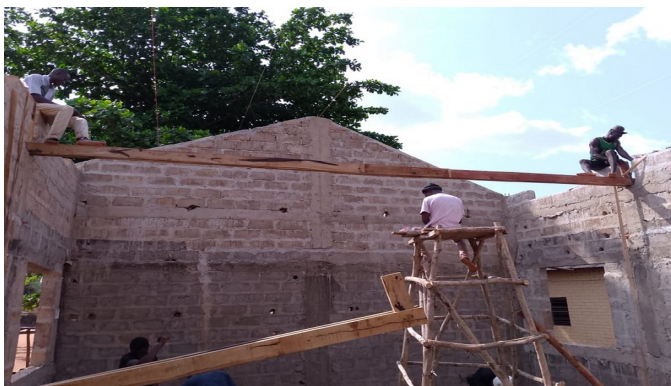
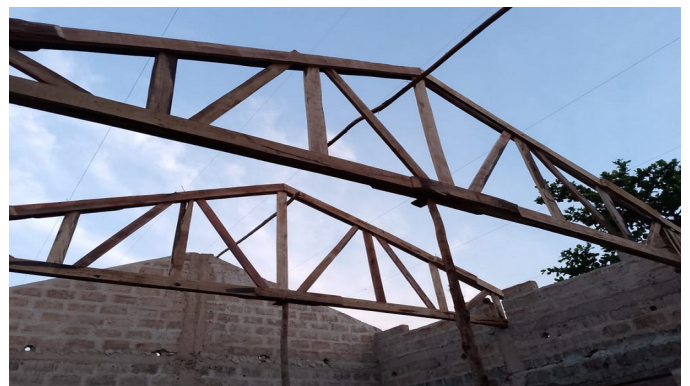
Then the cross ties are made

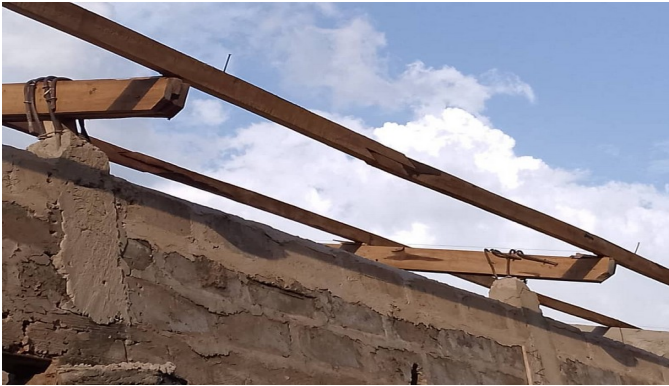
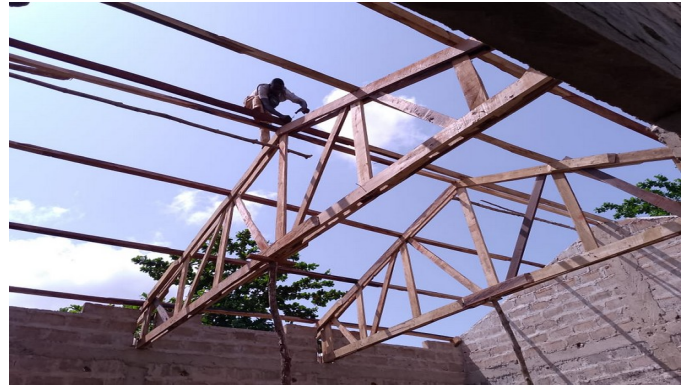
The cross ties are lashed by means of the iron rods of the pillars. The longitudinal planks are attached.

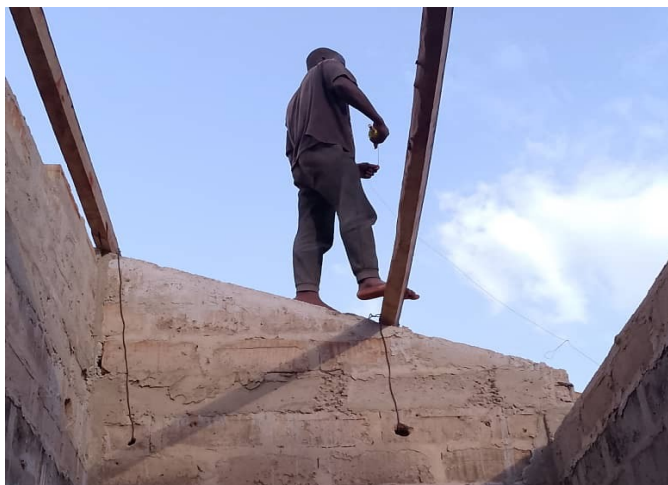
The entire roof structure is finally attached to the building with smooth iron rods.

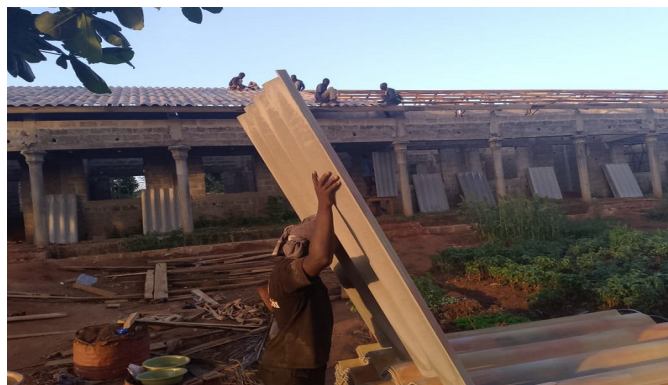
Then the roofing sheets are screwed on.

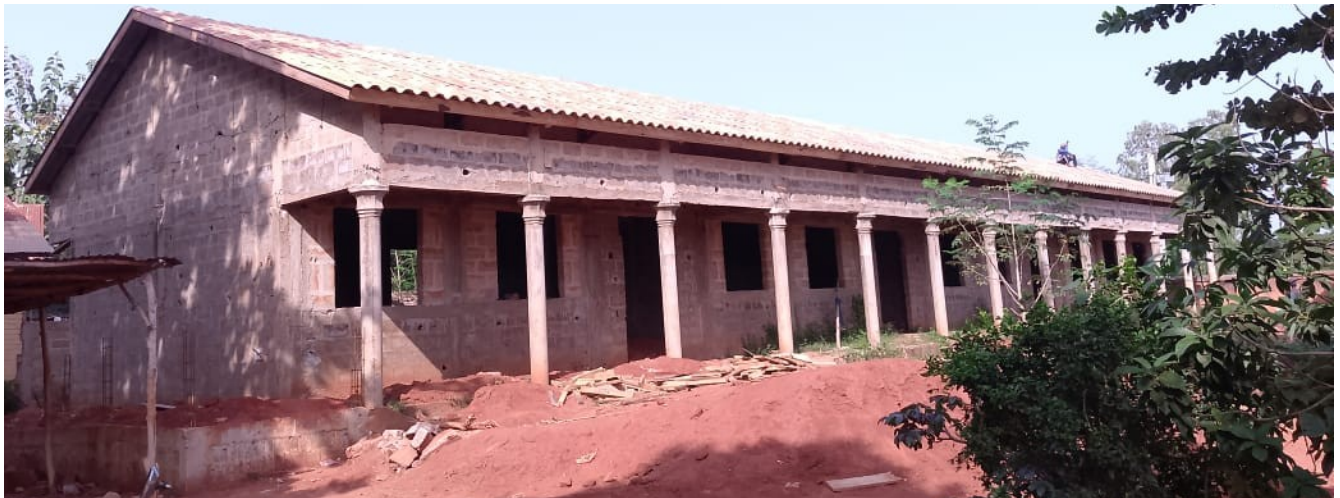
The building from the front and back side.
