**1<sup>st</sup> work report**  
(December 4, 2024 to February 18, 2025)  
**on the construction of one school building holding 2  
classrooms, one office, one storage place and toilets  
for the public preschool of Tchaladé  
district of Ouaké-Center  
municipality of Ouaké  
Republic of Benin**

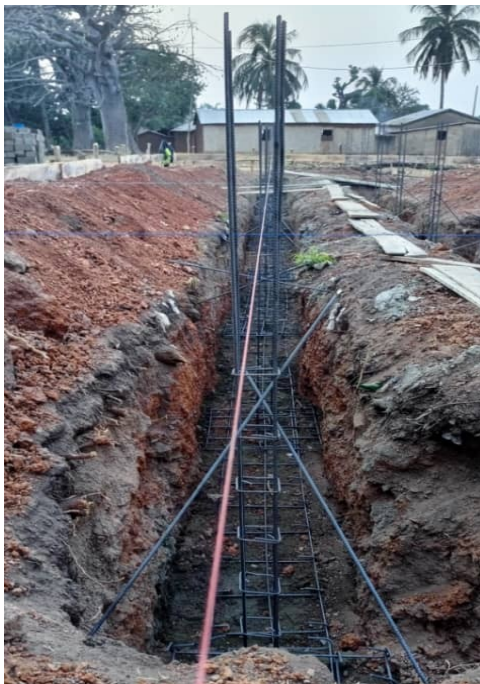
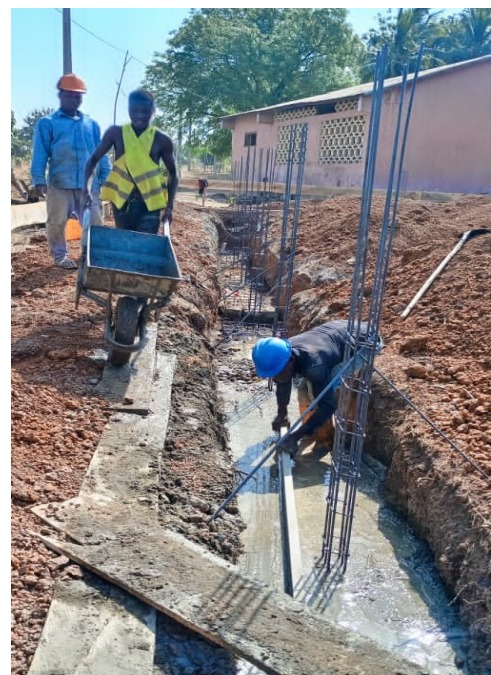
Once the foundation trenches have been dug, the masons pour the first concrete base and place the iron reinforcement. The pillars are then positioned. Thanks to the batter board, this task is relatively easy. The second layer of concrete is poured on top.

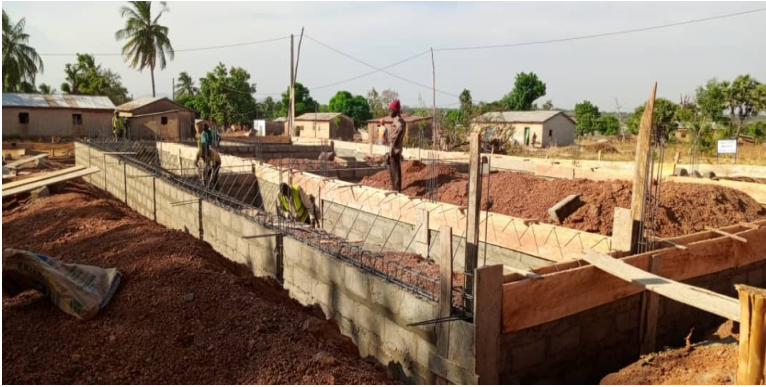
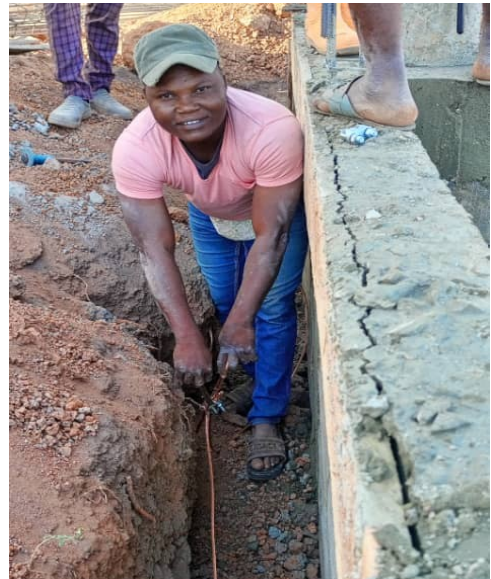
After the foundation base has dried, the building blocks are placed and the foundation walls grow in no time.

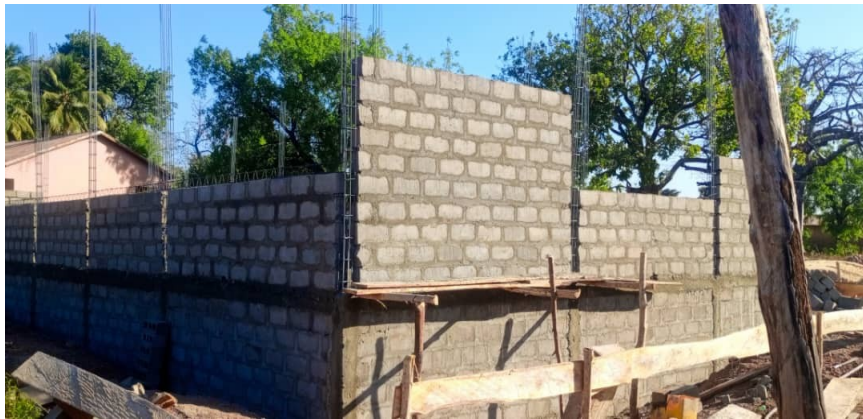
The lower iron anchor is in place. It is being sheathed and cast.  
The electrician is installing the grounding.

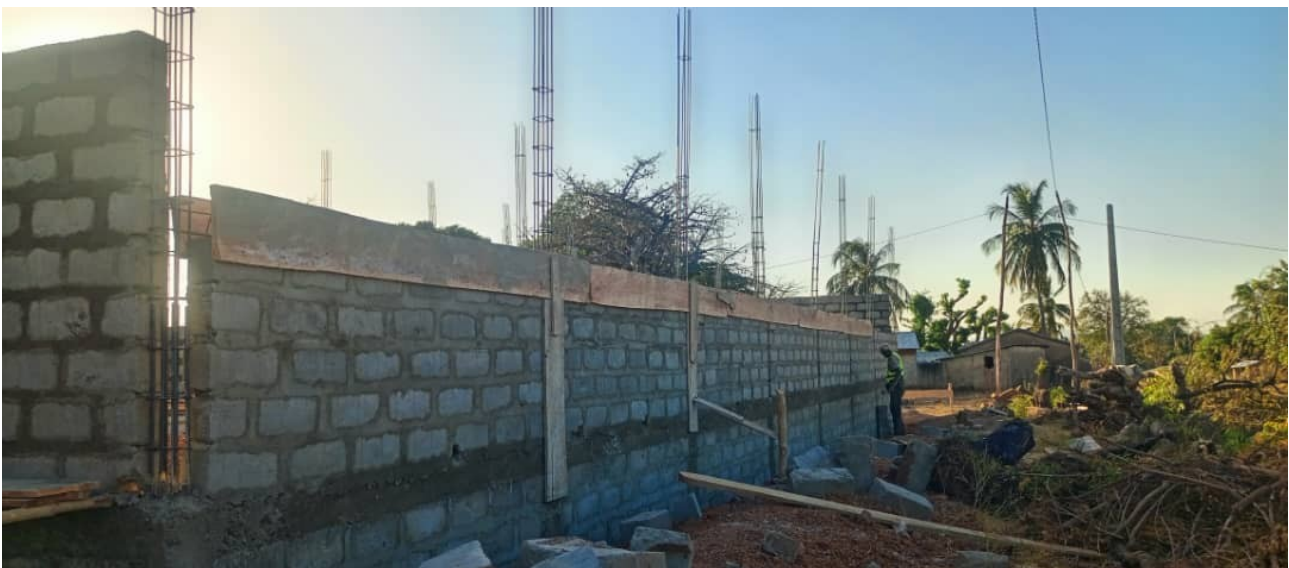
The walls are built on the lower iron anchor. A small iron anchor is inserted below the window openings.

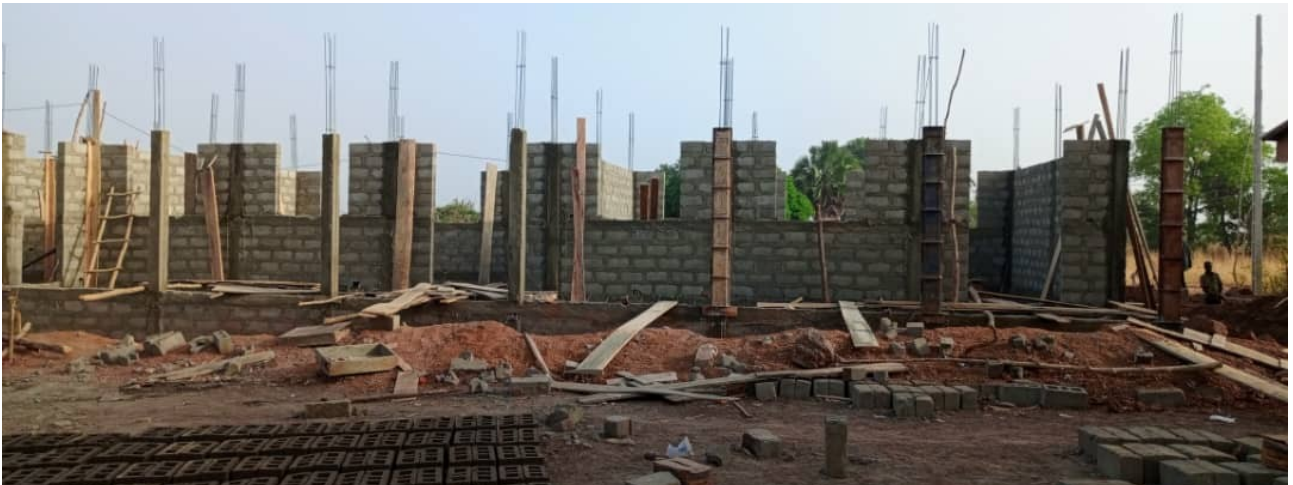
The veranda pillars are cast.

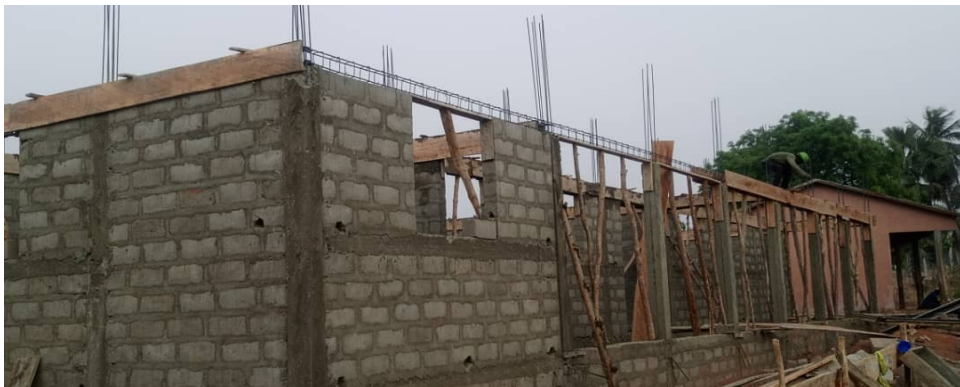
At this height, the upper iron anchor is prepared and cast in one piece.

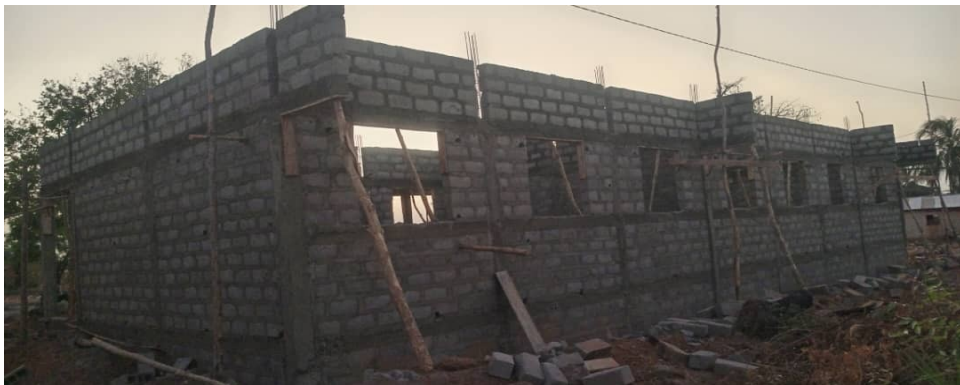
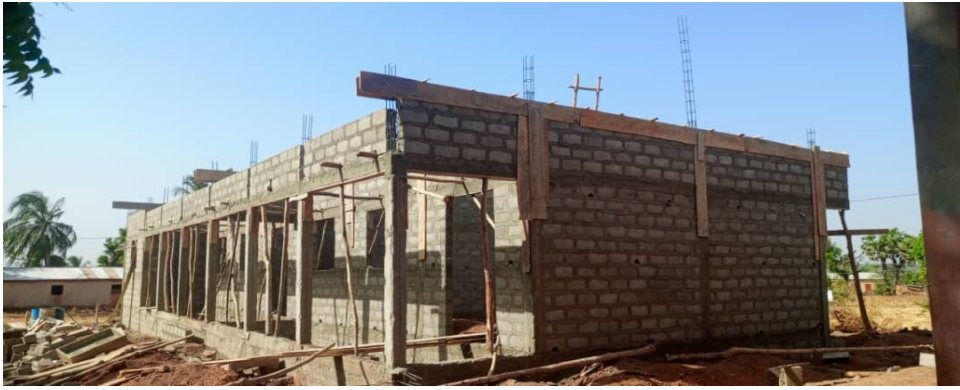
And on we go! The walls are raised up to the iron anchor below the roof, and this iron anchor is cast.

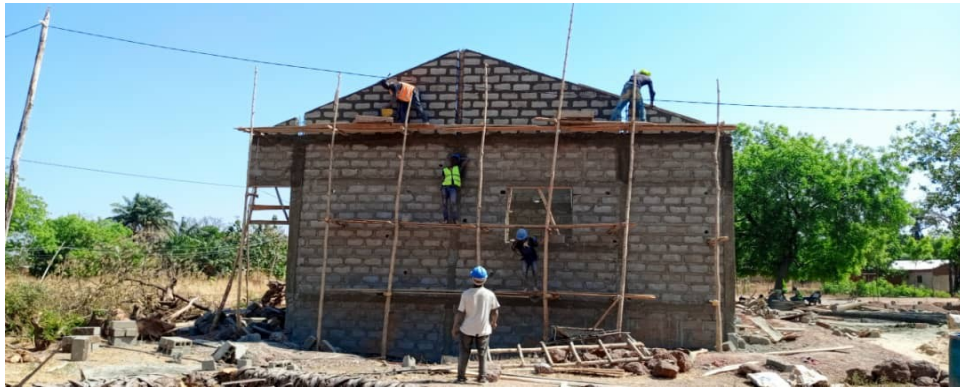
The gables are built above

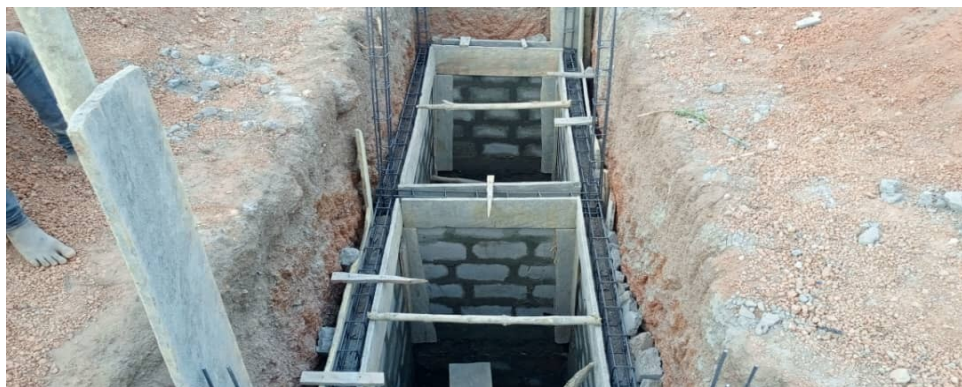
While the walls dry, the bricklayers begin to brick up the toilet pit.

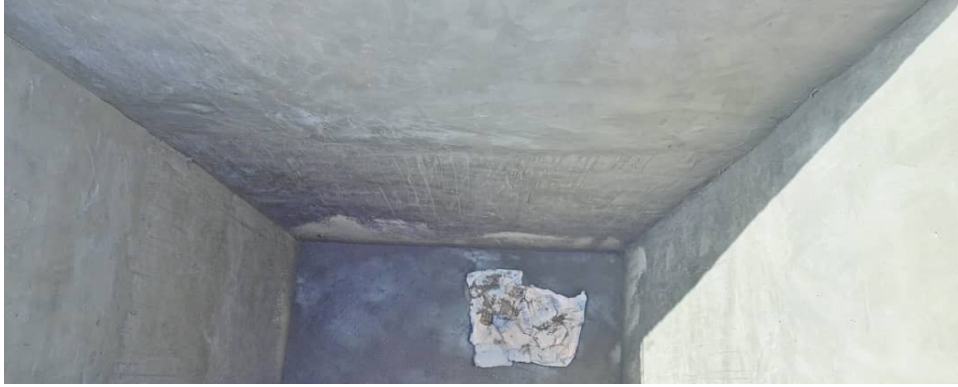
The pit is plastered inside with Sikalit and Sikalatex

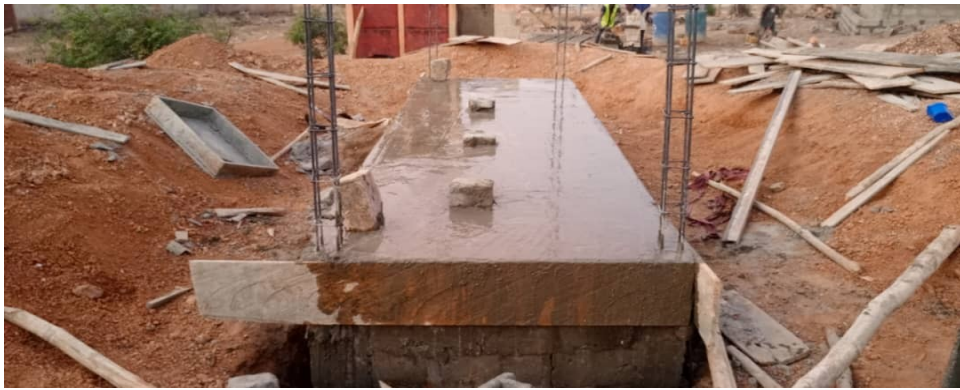
Finally, the pit is closed.

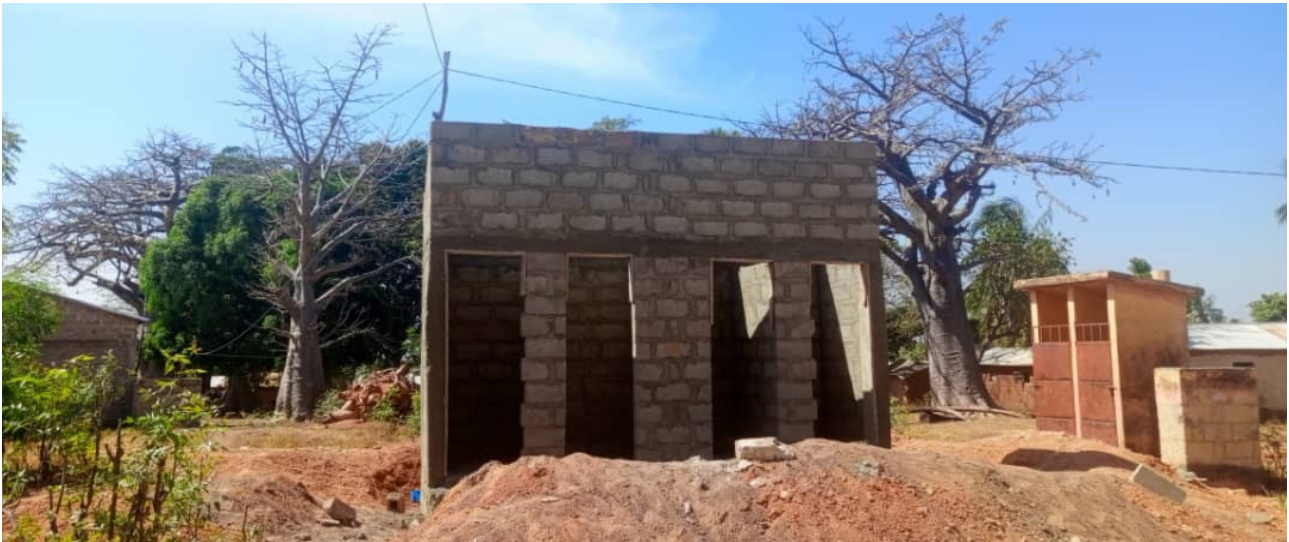
The toilet block is built on the closure plate.

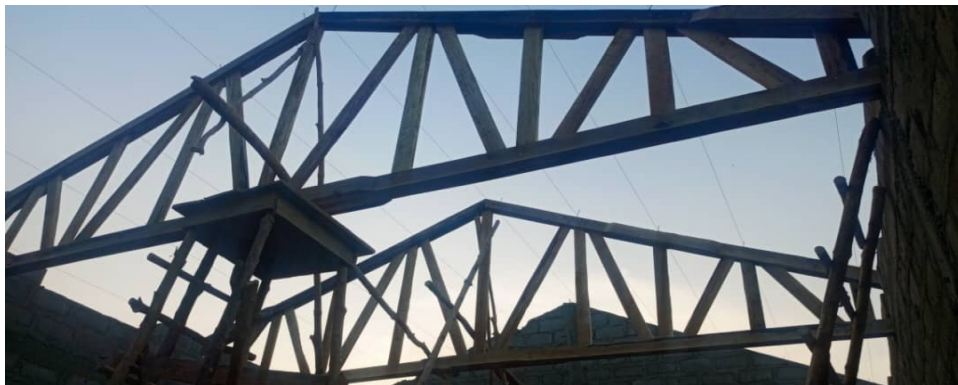
Then the cross ties are made.

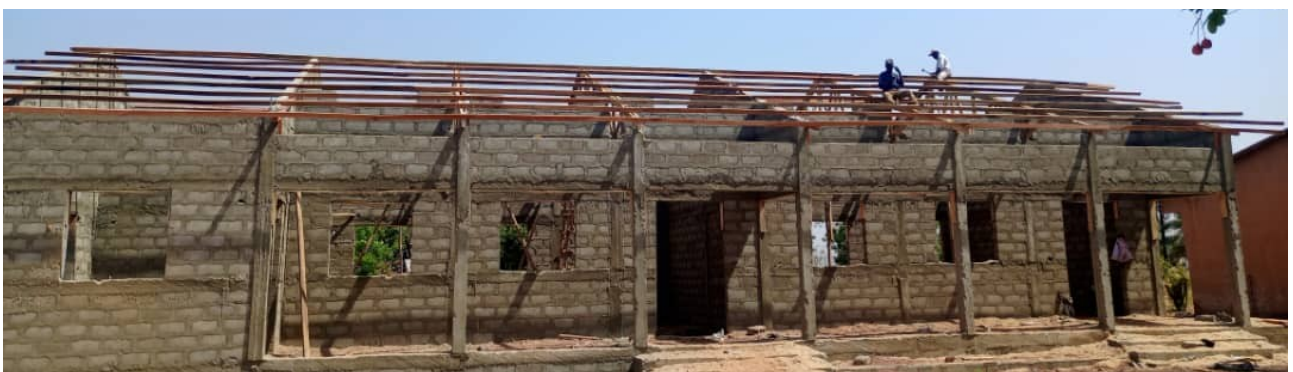
The longitudinal planks are attached on to the cross ties.

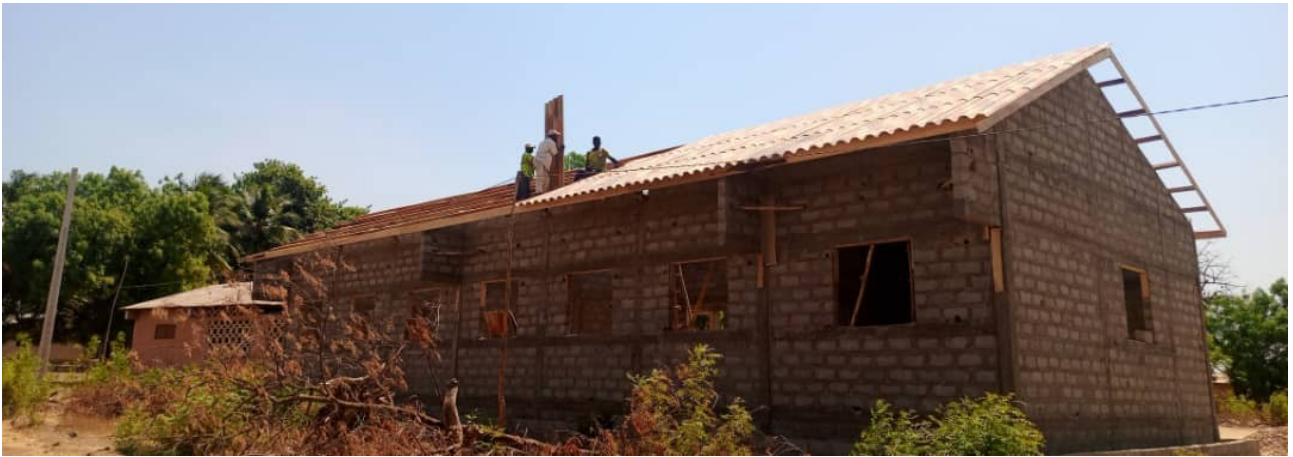
Finally, the roofing sheets are screwed on the roof truss.
